Independently certified audit of the long term
on-site performance of continuously anodised
aluminium panels on exterior architectural
applications in Continental Europe

In 2002/3, Coil commissioned Dr. Laszlo Palffy, through his consultancy, Straditech, to jointly visit, with Coil technical staff, a number of buildings where continuously anodised panels had been extensively employed in the construction of the facade. Dr. Palffy has significant experience of the technology of anodising of aluminium.

The purpose of this audit was to assess the real long term on-site performance of continuously anodised panels compared to accelerated laboratory testing on which earlier conclusions had been based.

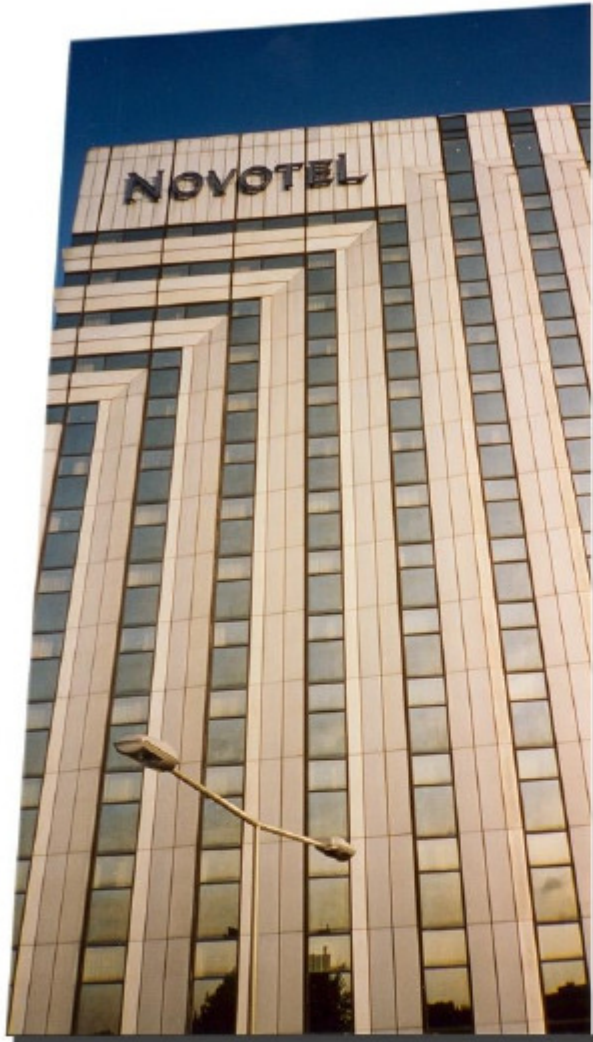
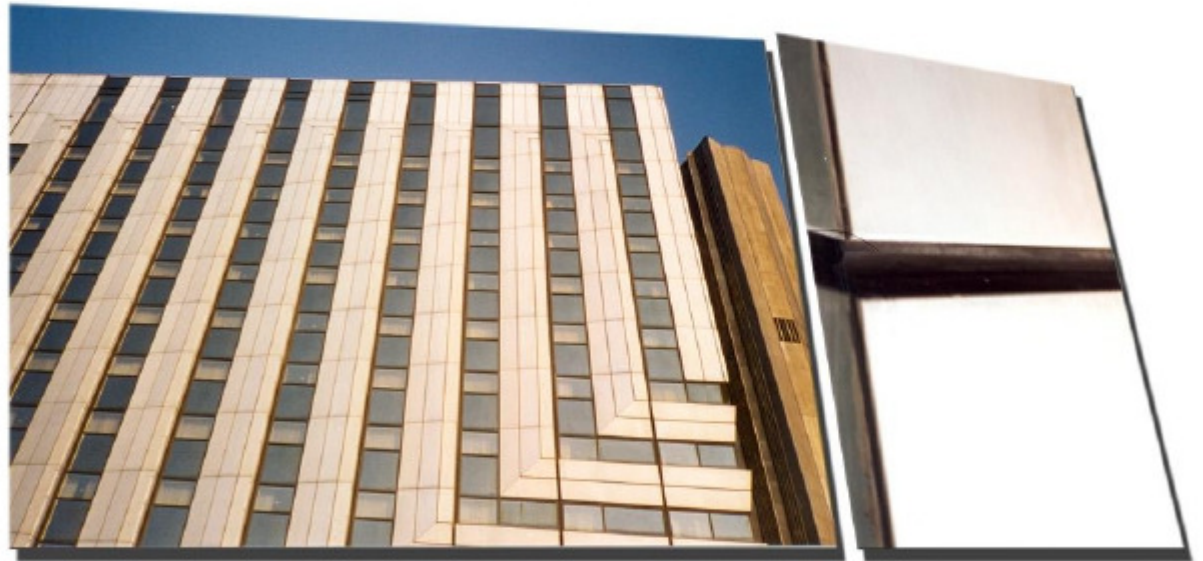
| Address of building | COMPLEXE D'HOTEL NOVOTEL-IBIS 4,Boulevard de Neuilly 92081 PARIS-LA-DEFENSE, FRANCE |

| Visible signs of corrosion or surface degradation | None |
| Conclusion | After 20 years, no apparent corrosion and no reduction in anodic film despite high density urban environment |

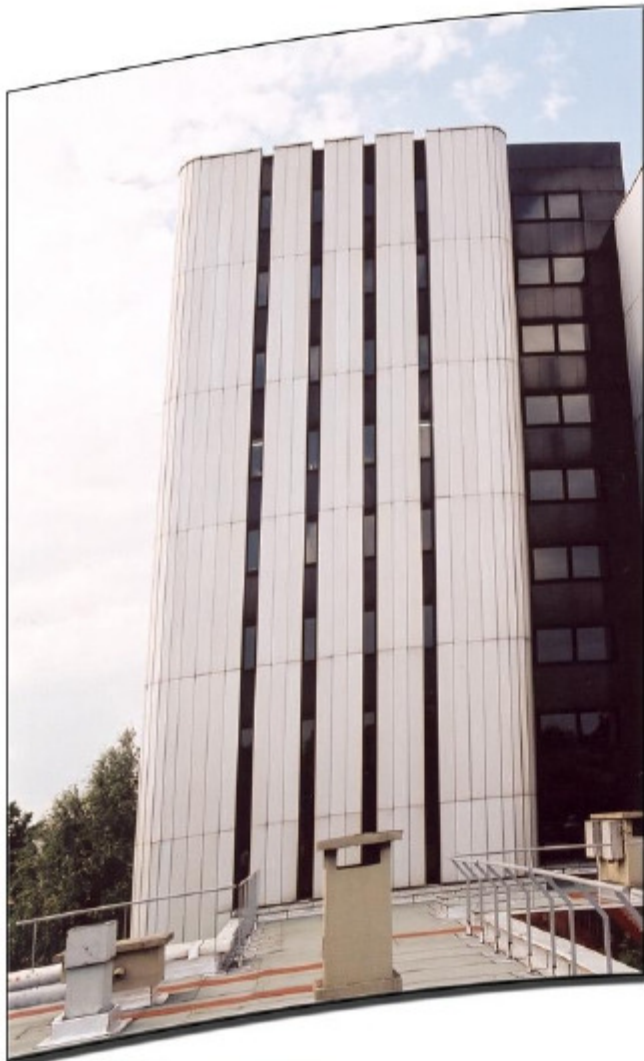
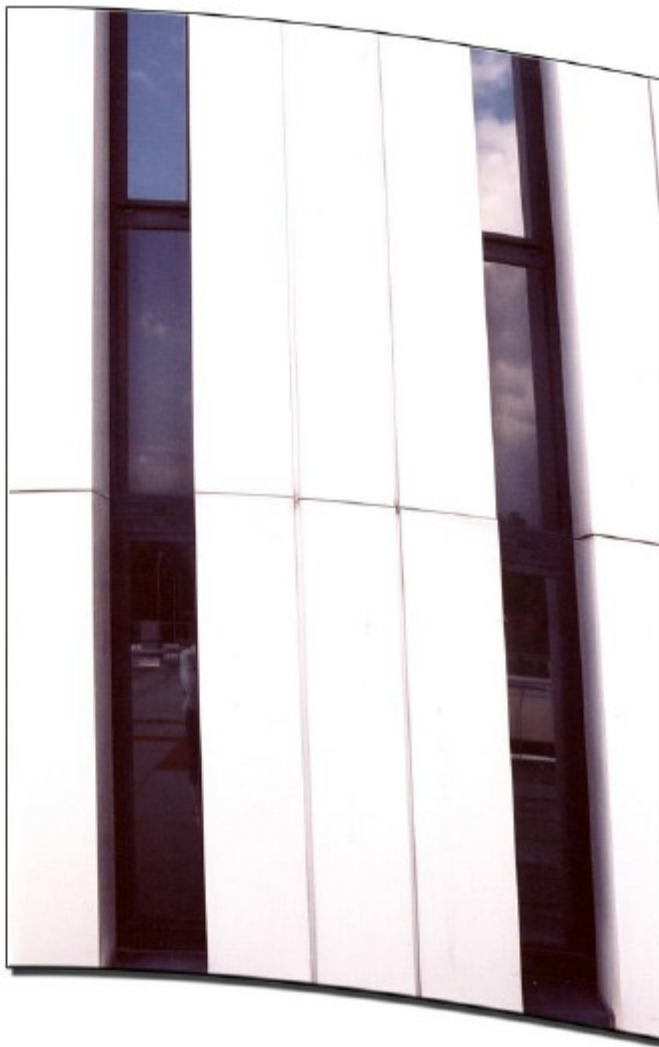
| Address of building | LES ARCHIVES DEPARTEMENTALES DES HAUTS DE SEINE 137, avenue Joliot Curie, 92023 NANTERRE-FRANCE |

| Visible signs of corrosion or surface degradation | None |
| Conclusion | After 24 years, no apparent signs of corrosion and no reduction in anodic film despite high density urban environment. |

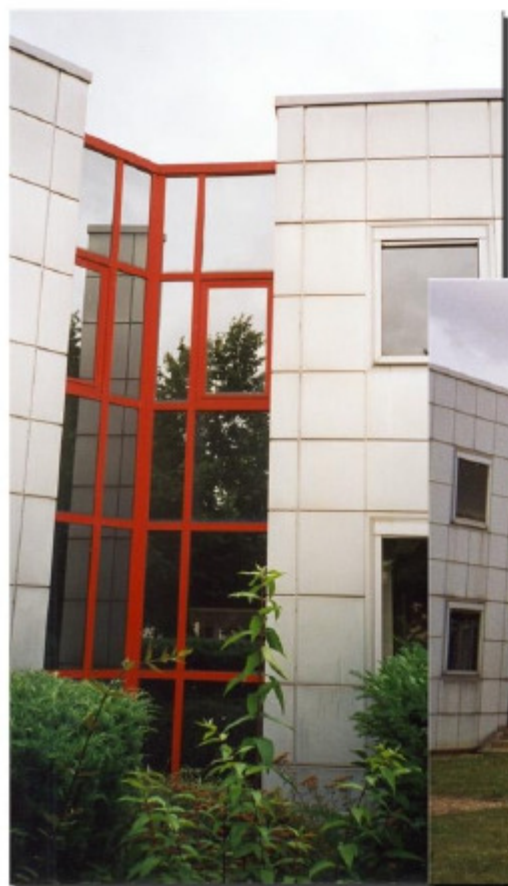
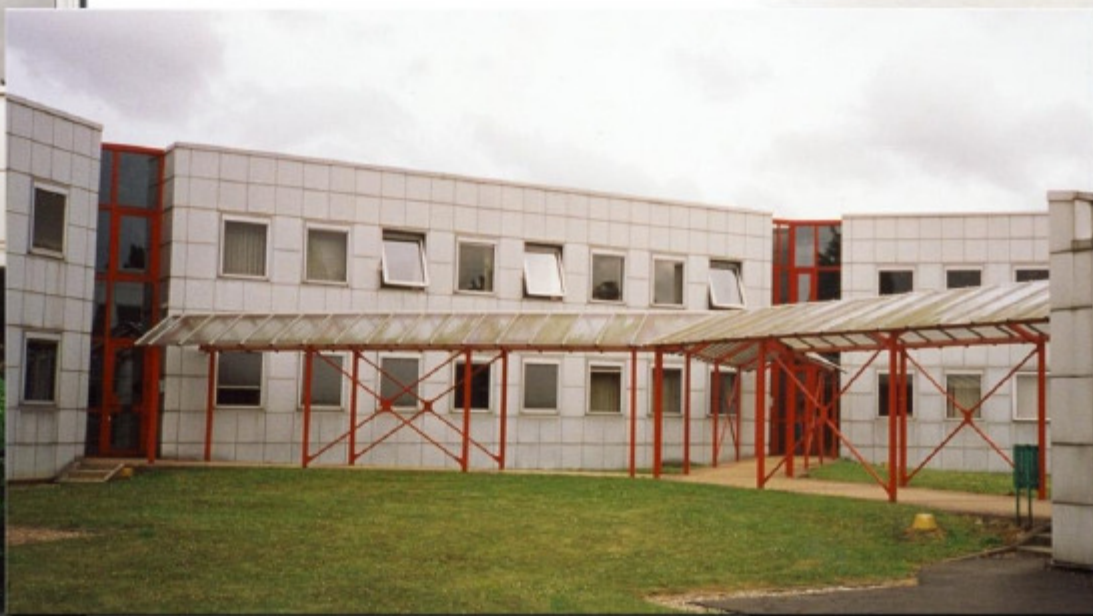
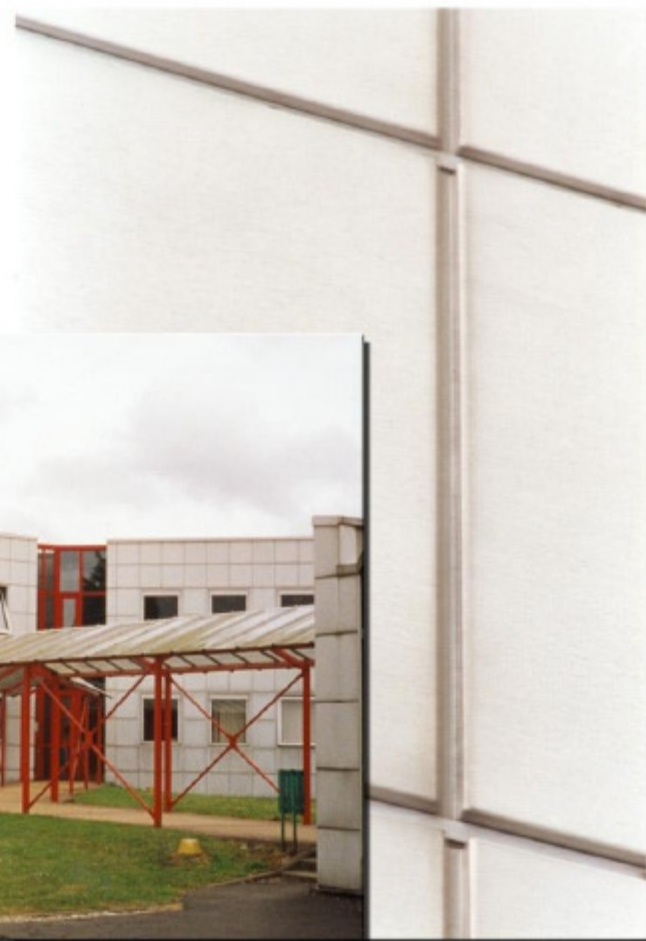
| Address of building | CENTRE EDF-GDF 4, avenue du Pacifique, ZA Courtaboeuf, 91940 LES ULIS - FRANCE |

| Visible signs of corrosion or surface degradation | None |
| Conclusion | After 20 years, no apparent signs of corrosion and no reduction in anodic film. |

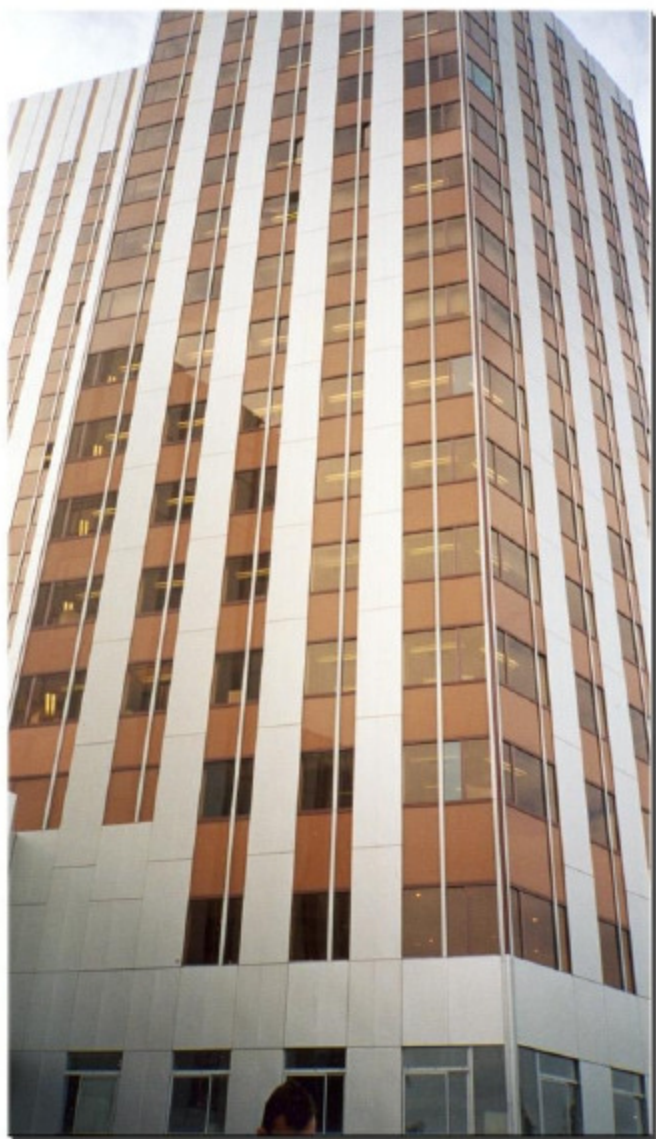
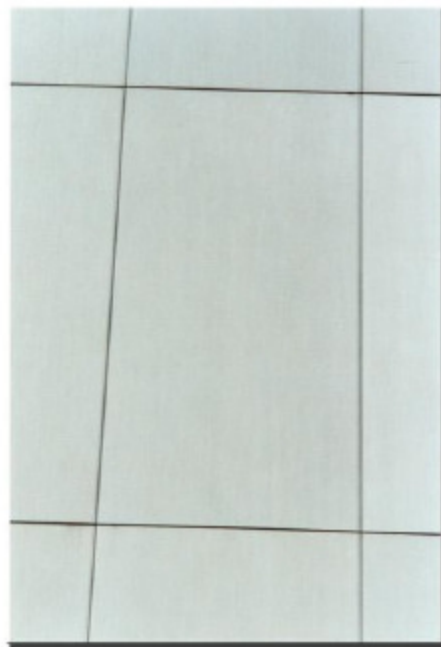
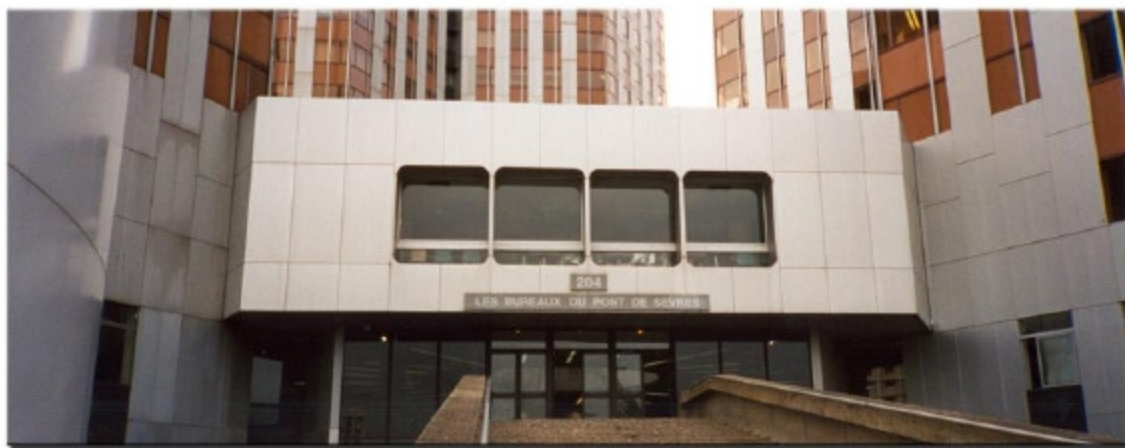
| Address of building | LES BUREAUX DU PONT DE SEVRES 204, Pont de Sèvres 92510 BILLANCOURT-FRANCE |

| Visible signs of corrosion or surface degradation | None |
| Conclusion | After 27 years, no apparent signs of corrosion and no reduction in anodic film despite high density urban environment. |

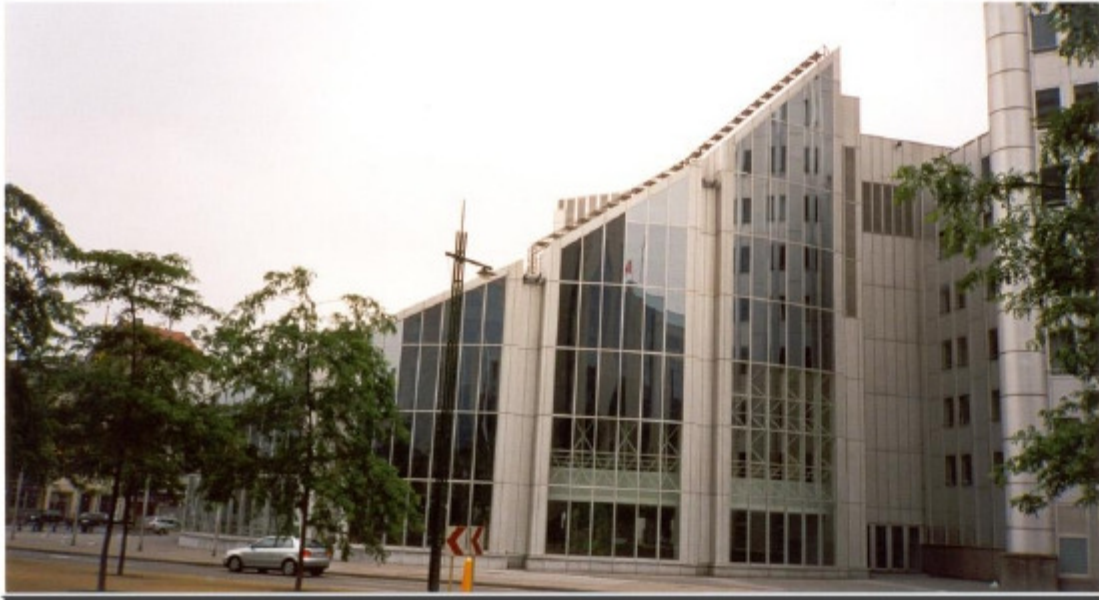
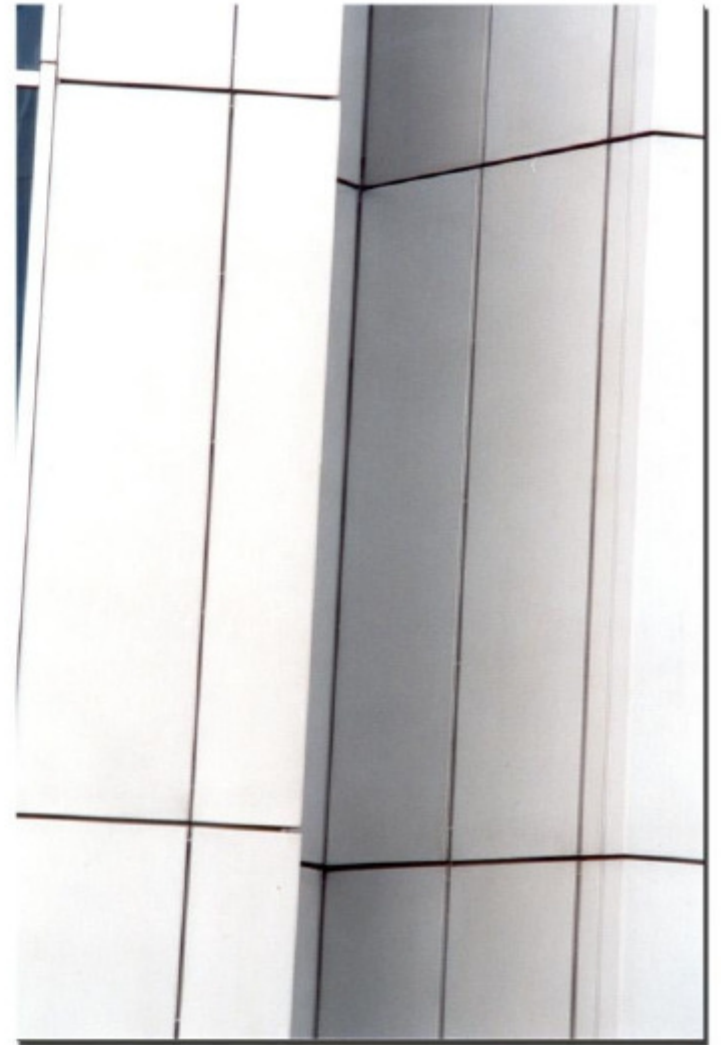
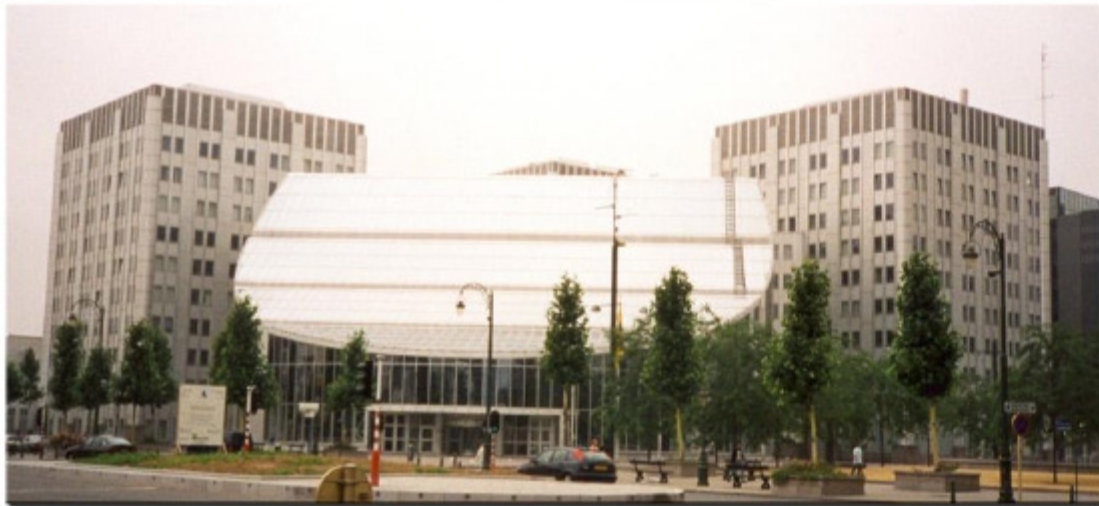
| Address of building | MINISTERE DE LA COMMUNAUTE FLAMANDE - BATIMENT BAUDOUIN 30, avenue Albert II 1000 BRUXELLES-BELGIUM |

| Visible signs of corrosion or surface degradation | None |
| Conclusion | After 23 years, no apparent signs of corrosion and no reduction in anodic film despite high density urban environment. |

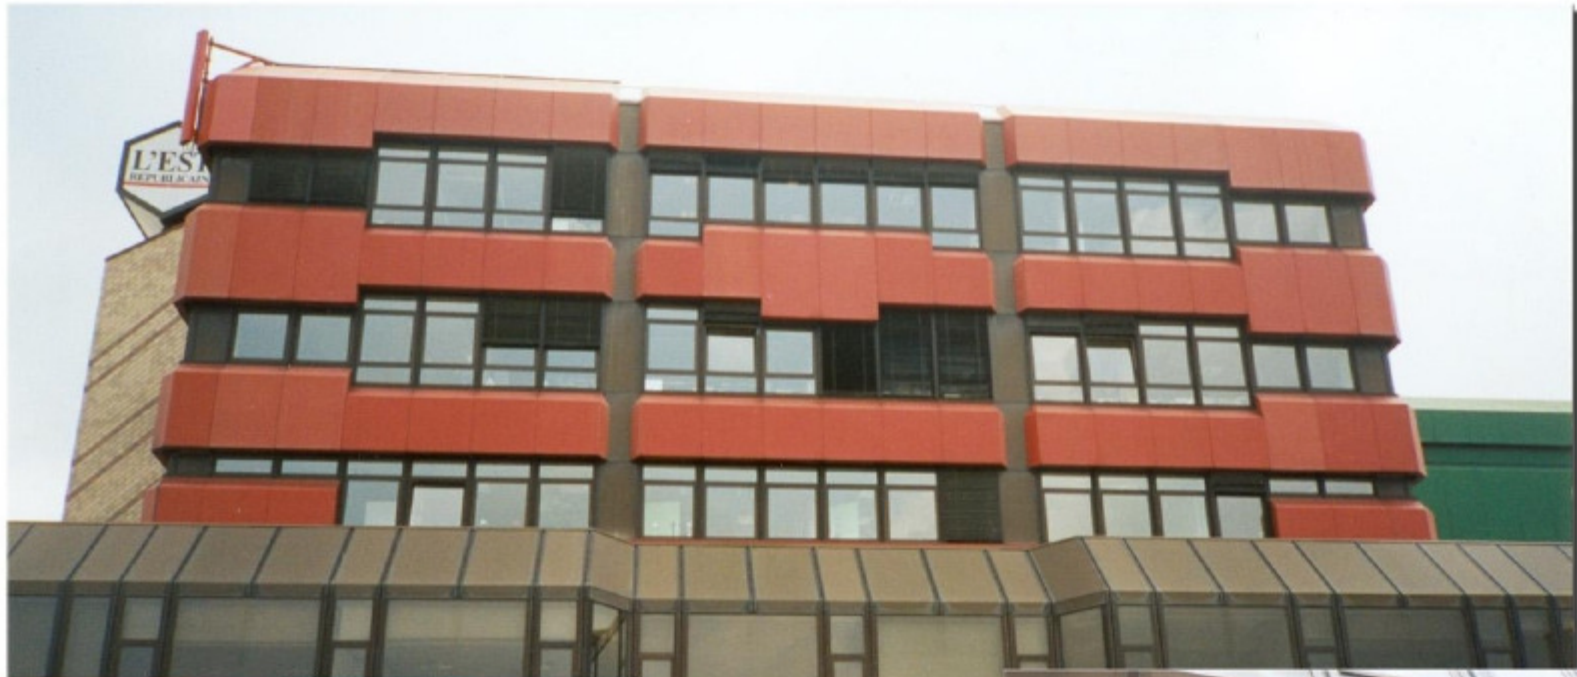
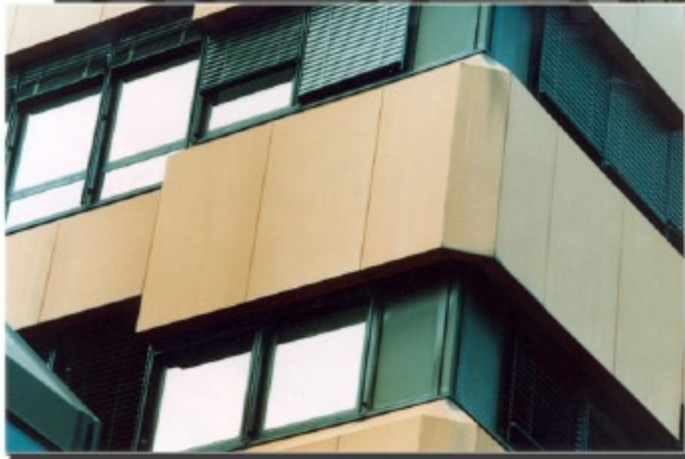
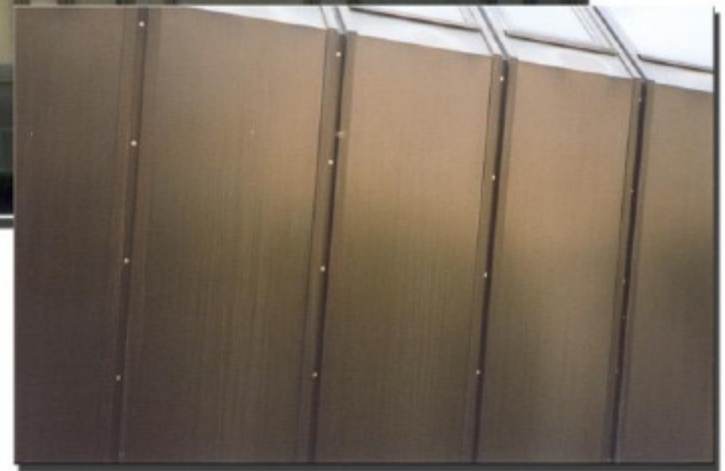
| Address of building | L'EST REPUBLICAIN 54180 HOUEMONT (NANCY) - FRANCE |

| Visible signs of corrosion or surface degradation | None |
| Conclusion | After 20 years, no apparent signs of corrosion and no reduction in anodic film. |

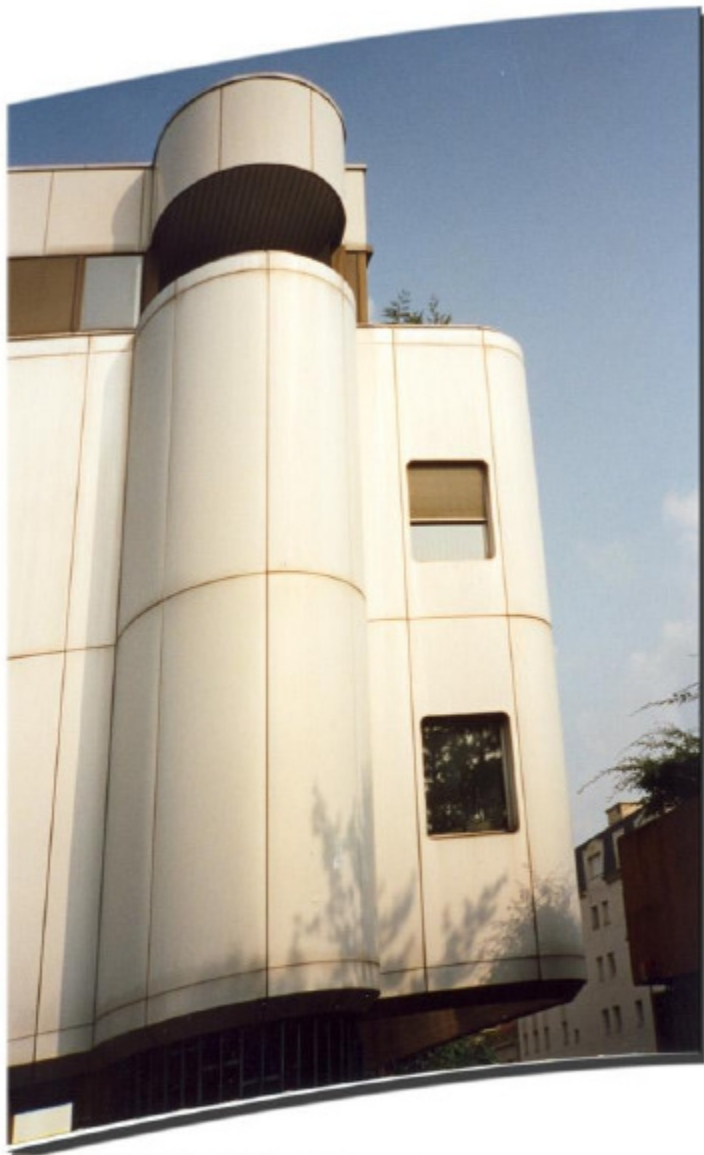
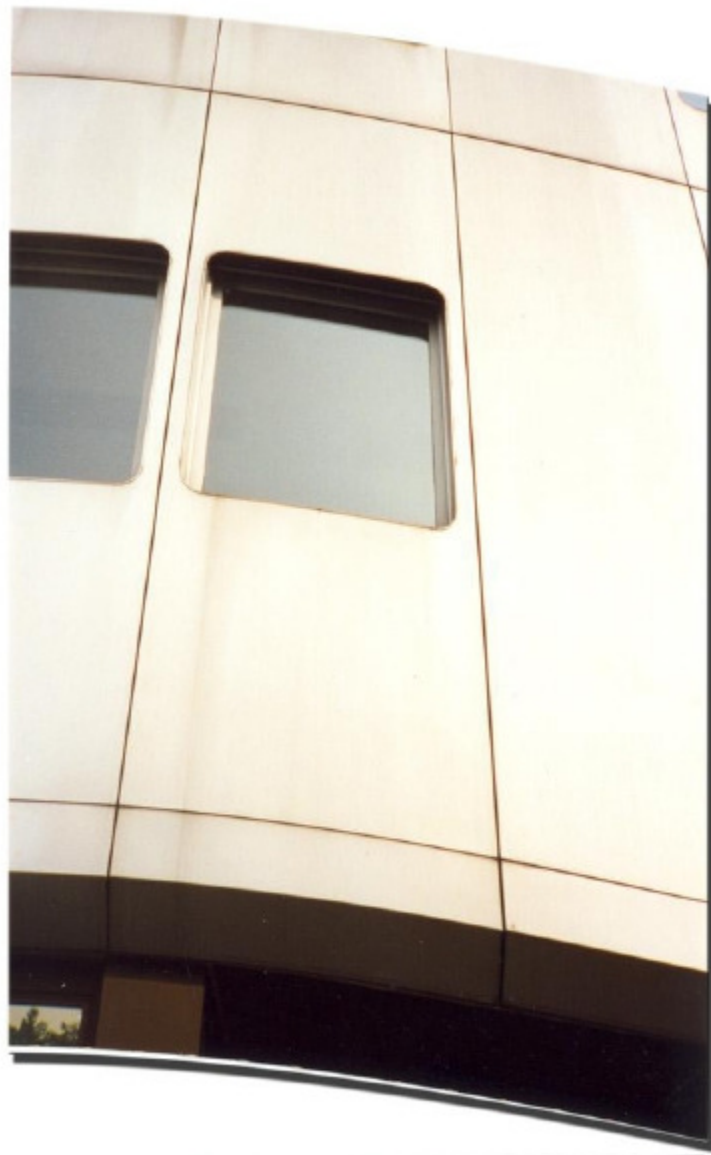
| Address of building | PERNOD – RESIDENCE BERENICE 13, Boulevard Charles V 54000 NANCY-FRANCE |

| Visible signs of corrosion or surface degradation | None |
| Conclusion | After 21 years, no apparent signs of corrosion and no reduction in anodic film. |

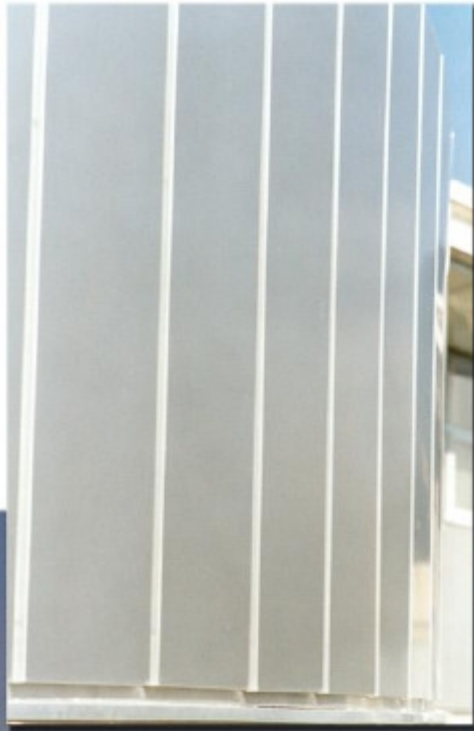
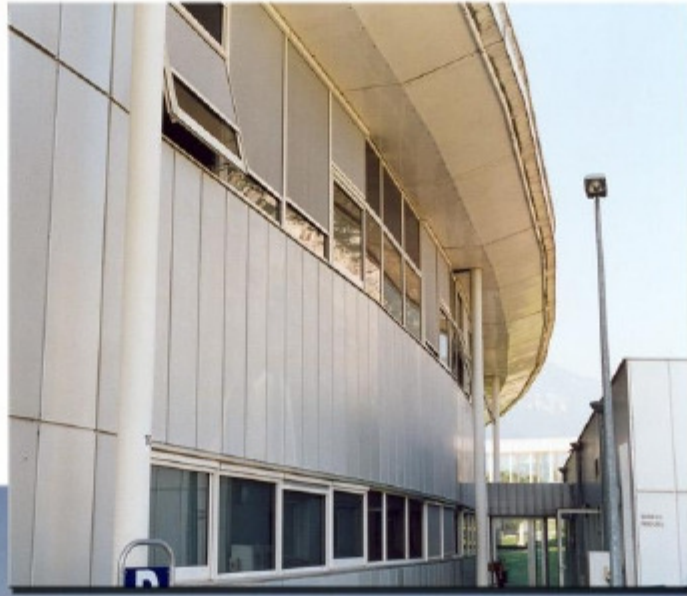
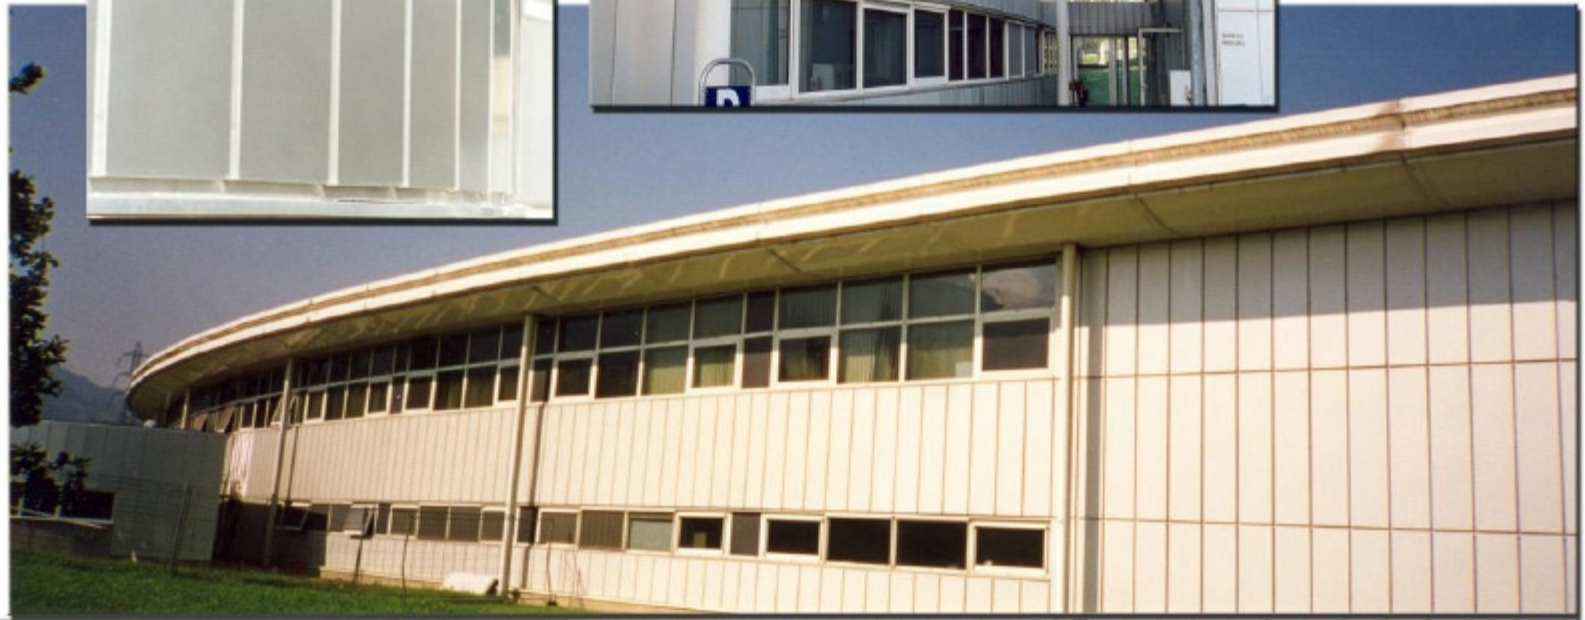
| Address of building | EUROPEAN SYNCHROTRON RADIATION FACILITY 6, rue Jules Horowitz 38000 GRENOBLE-FRANCE |

| Visible signs of corrosion or surface degradation | None |
| Conclusion | After 11 years, no apparent signs of corrosion and no reduction in anodic film despite high density, polluted environment. |

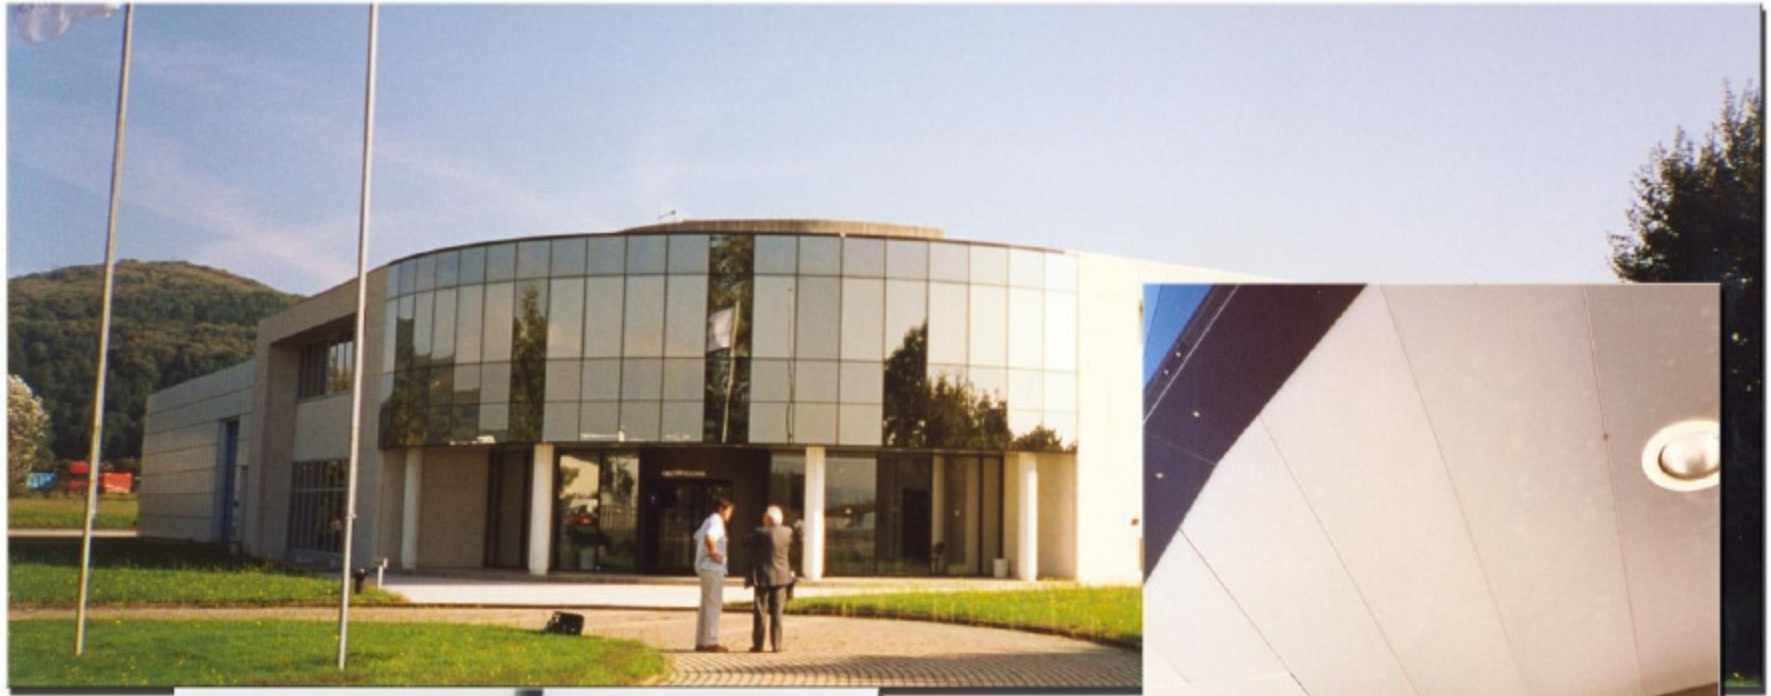
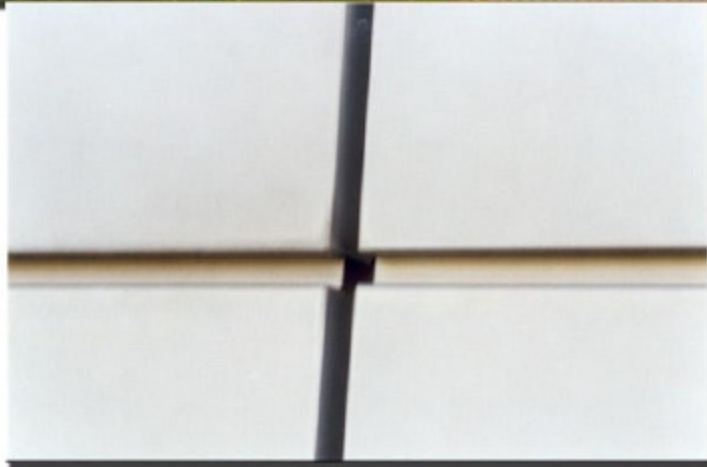
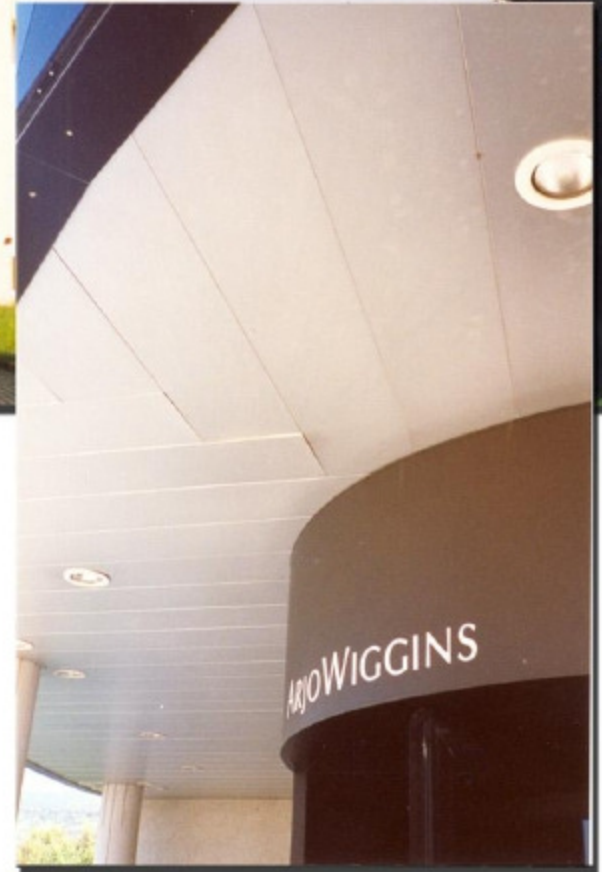
| Address of building | CENTRE DE RECHERCHE ARJO-WIGGINS 40, rue du Grand Champ 38140 APPRIEU (RIVES) - FRANCE |

| Visible signs of corrosion or surface degradation | None |
| Conclusion | After 13 years, no apparent signs of corrosion and no reduction in anodic film. |

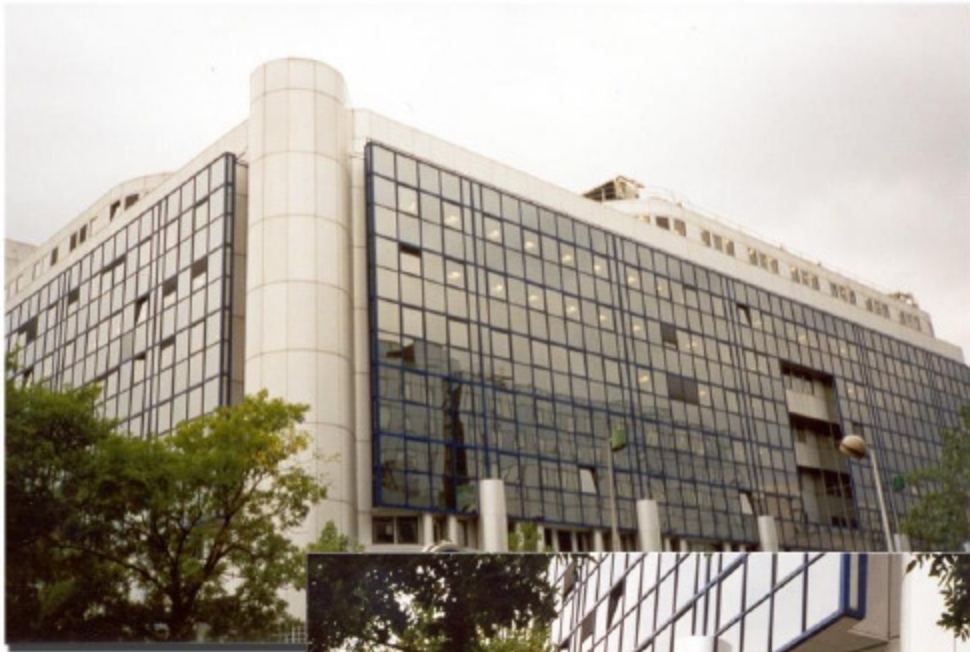
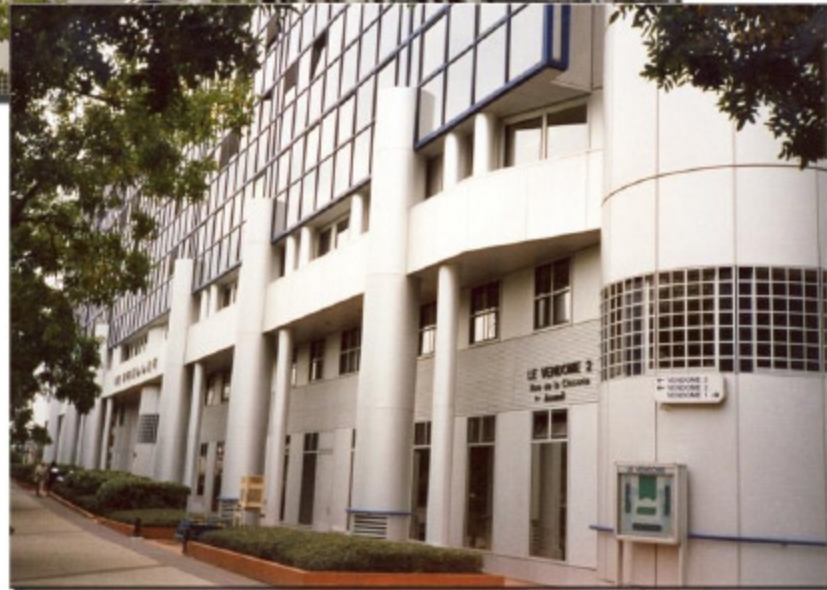
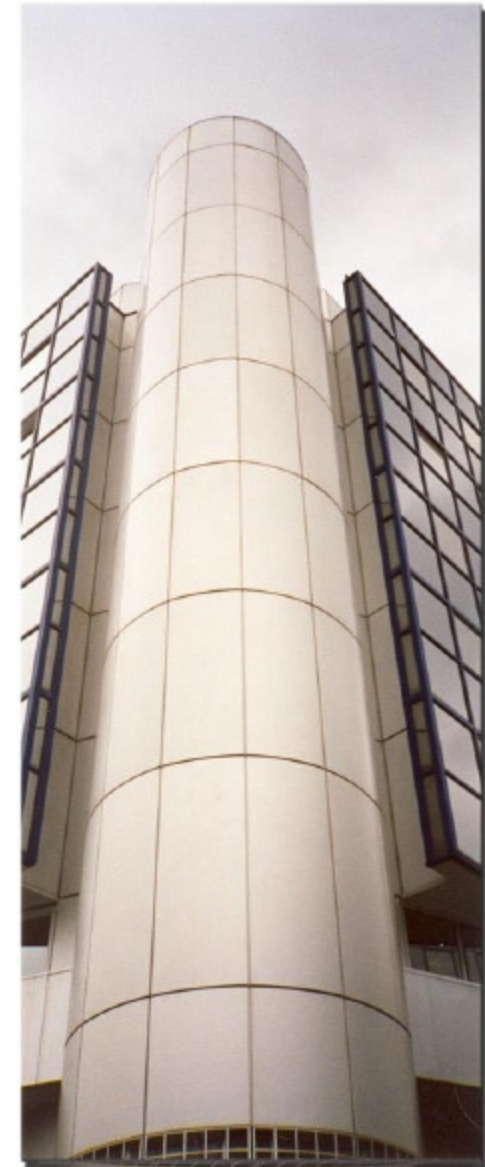
| Address of building | COMPLEXE DE BUREAUX – LE VENDÔME 26, rue de la Closerie 93160 NOISY-LE-GRAND - FRANCE |

| Visible signs of corrosion or surface degradation | None |
| Conclusion | After 14 years, no apparent signs of corrosion and no reduction in anodic film despite high density, polluted environment. |

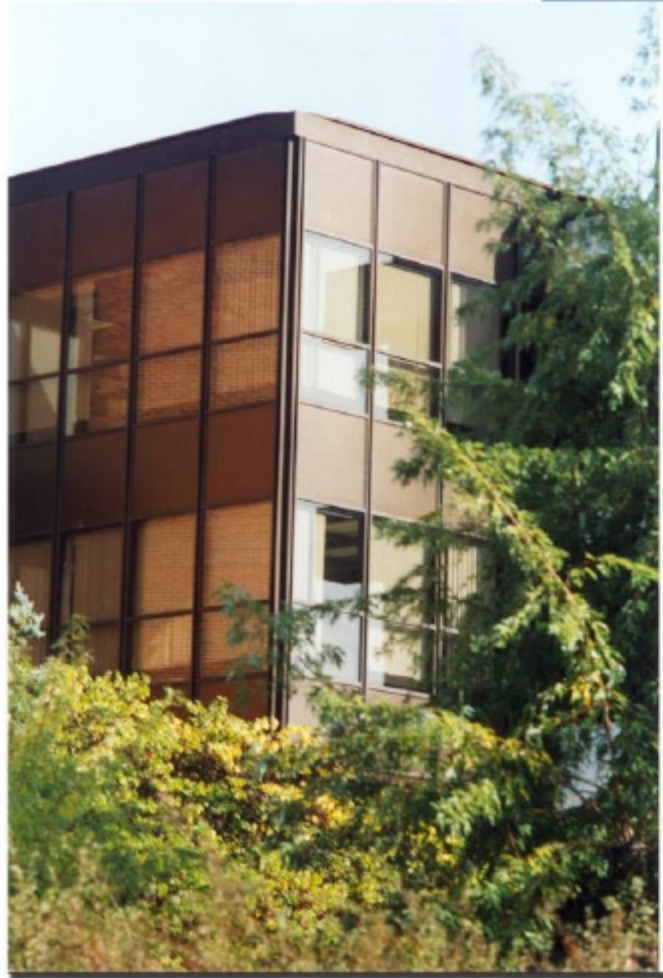
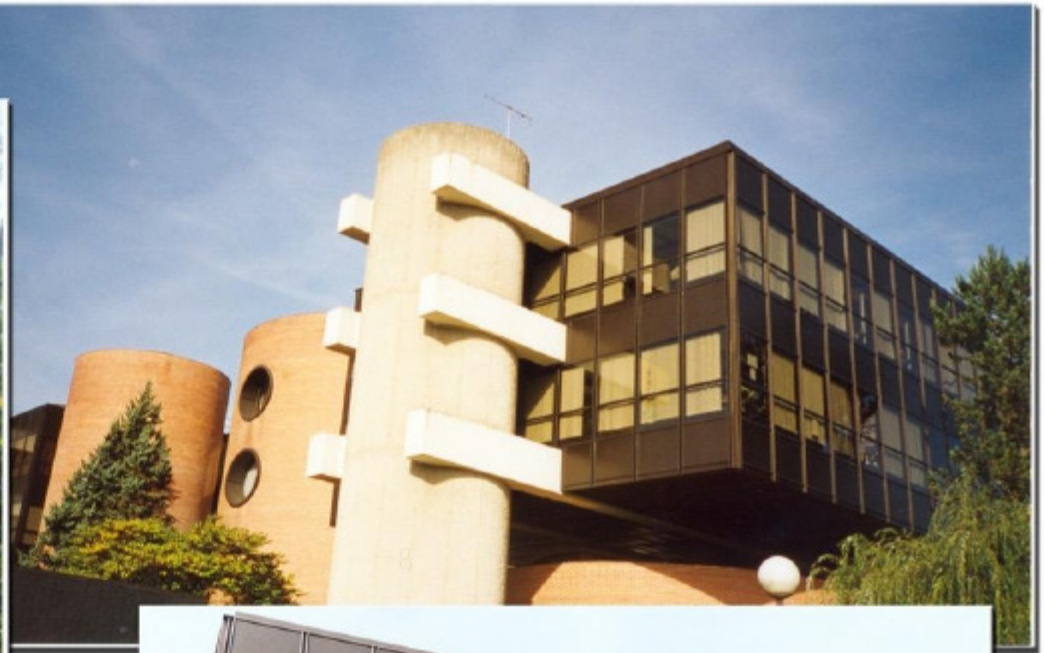
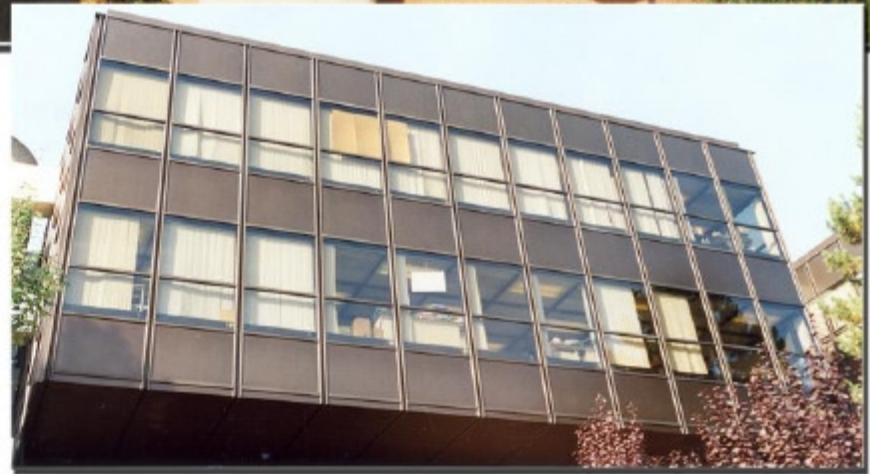
| Address of building | CAISSE REGIONALE DE CREDIT AGRICOLE 26, rue de la Godde 45800 SAINT JEAN DE BRAYE - FRANCE |

| Visible signs of corrosion or surface degradation | None |
| Conclusion | After 6 years, no apparent signs of corrosion and no reduction in anodic film. |

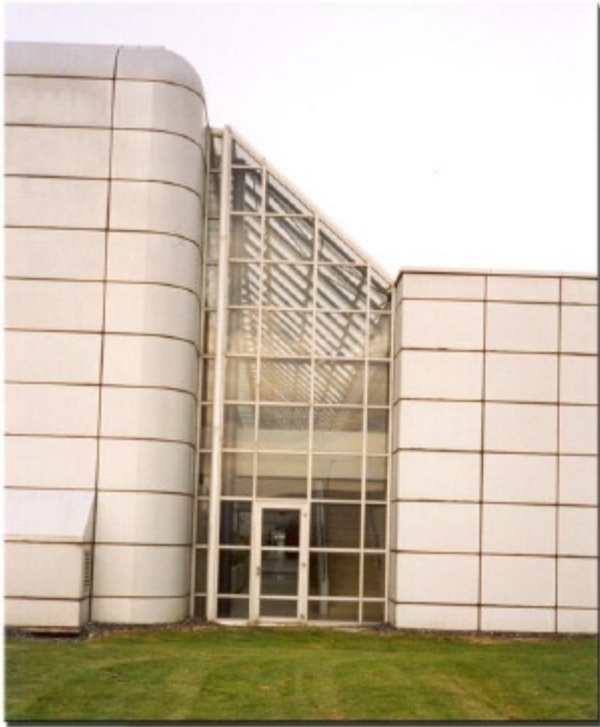
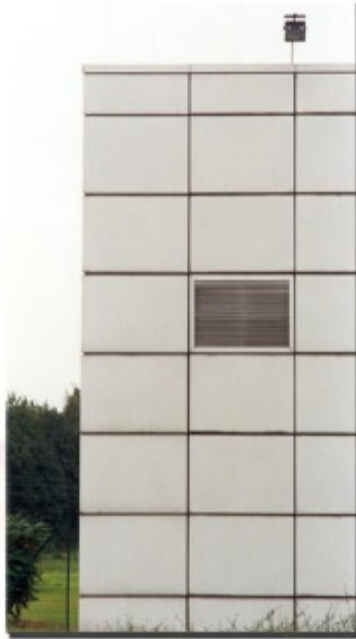
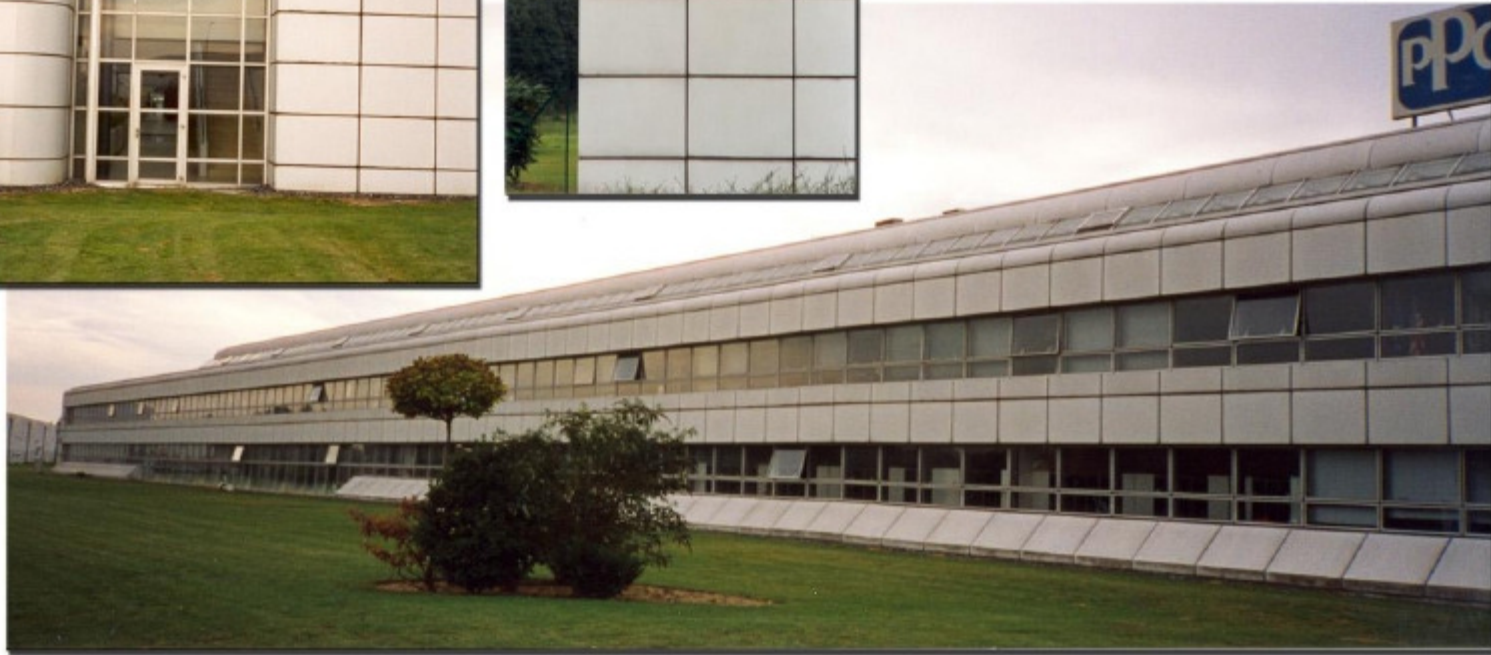
| Address of building | SIEGE ADMINISTRATIF ET CENTRE DE RECHERCHE - PPG INDUSTRIES Marly 3, Z.A.E.Les Dix Muids 59583 MARLY-FRANCE |

| Visible signs of corrosion or surface degradation | None |
| Conclusion | After 25 years, no apparent signs of corrosion and no reduction in anodic film. |
