Independently certified audit of the long term
on-site performance of continuously anodised
aluminium panels on exterior architectural
applications in Continental Europe

In 2002/3, Coil commissioned Dr. Laszlo Palffy, through his consultancy, Straditech, to jointly visit, with Coil technical staff, a number of buildings where continuously anodised panels had been extensively employed in the construction of the facade. Dr. Palffy has significant experience of the technology of anodising of aluminium.

The purpose of this audit was to assess the real long term on-site performance of continuously anodised panels compared to accelerated laboratory testing on which earlier conclusions had been based.

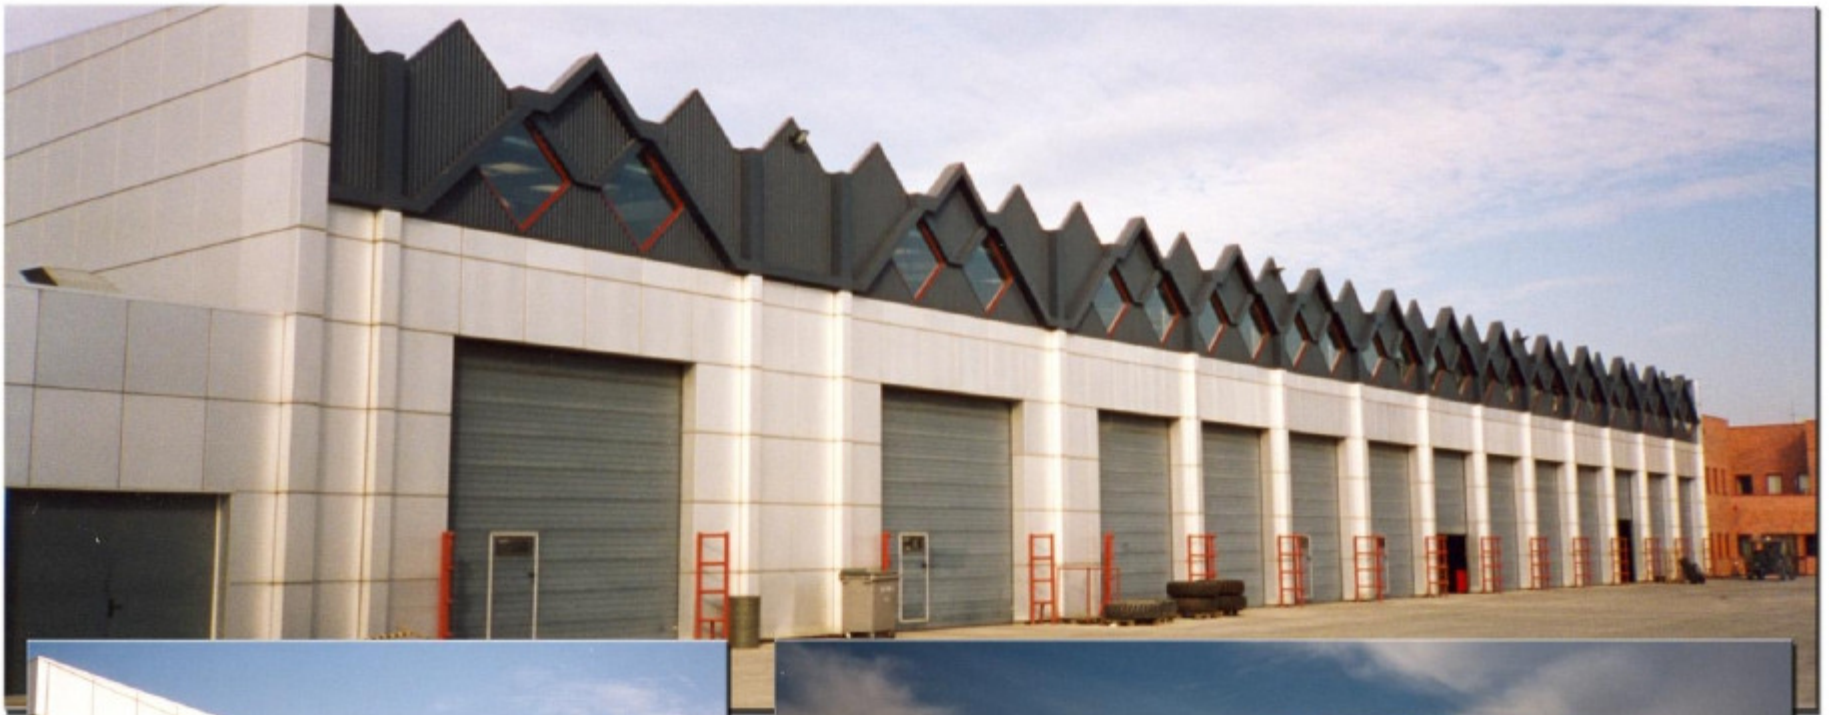
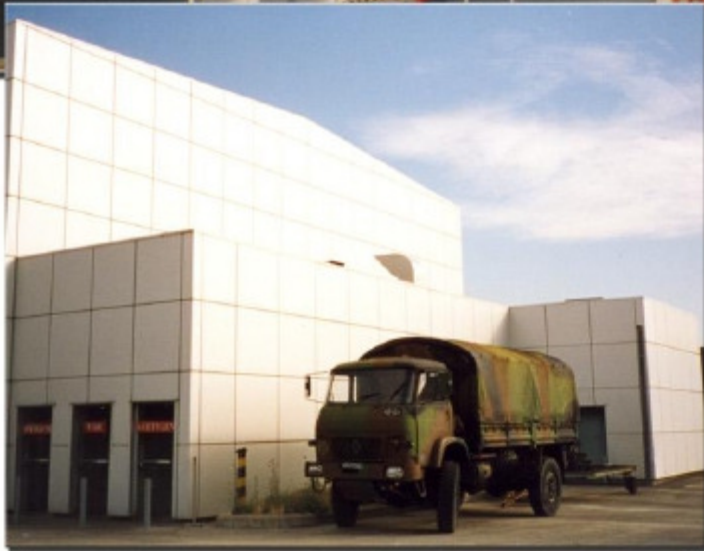
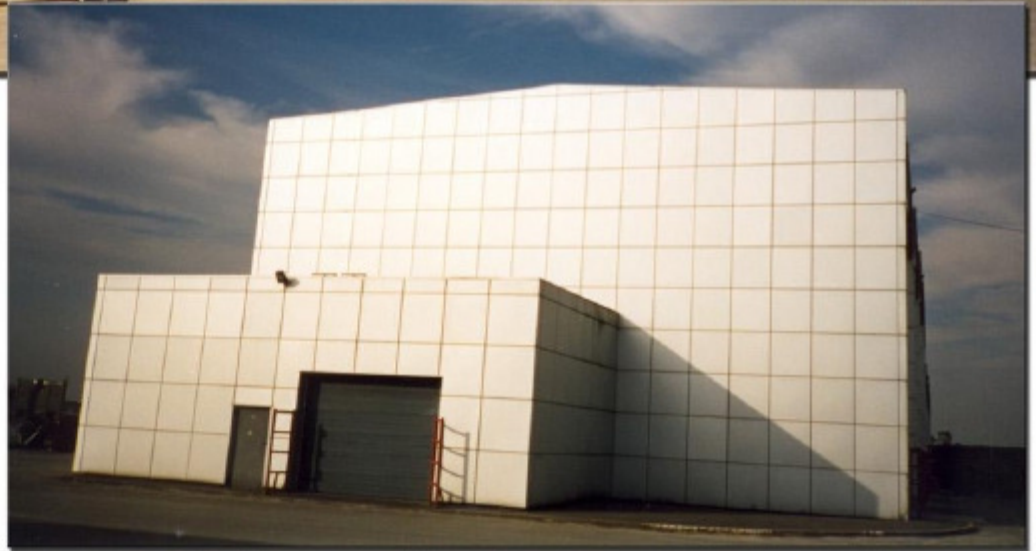
| Address of building | ECOLE SUPERIEURE D'APPLICATION DU GENIE - QUARTIER BERTHEZENE rue des Petites Mussés 49041 ANGERS - FRANCE |

| Visible signs of corrosion or surface degradation | None |
| Conclusion | After 14 years, no apparent signs of corrosion and no reduction in anodic film. |

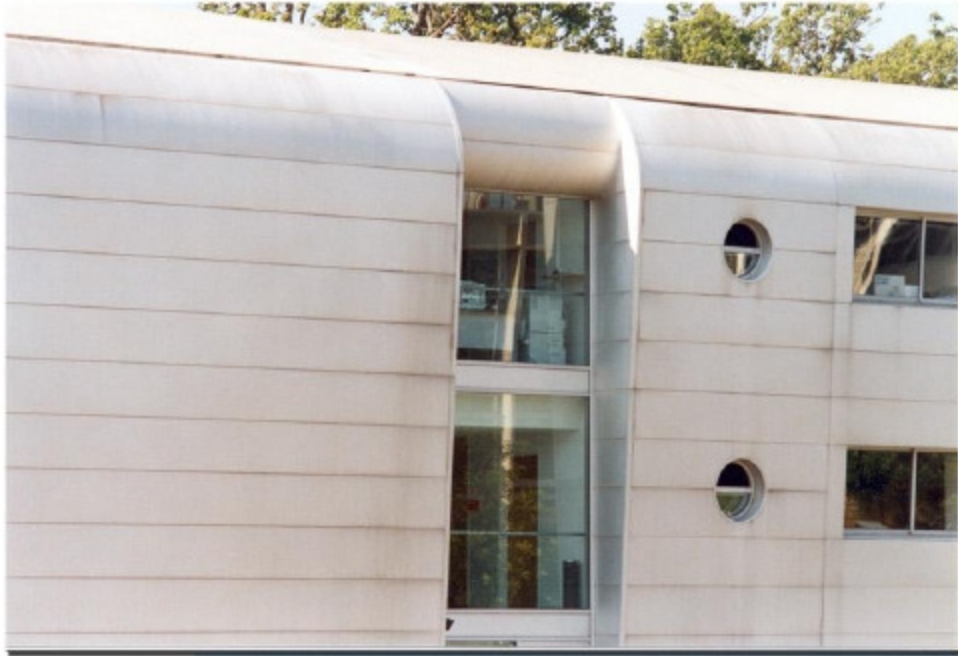
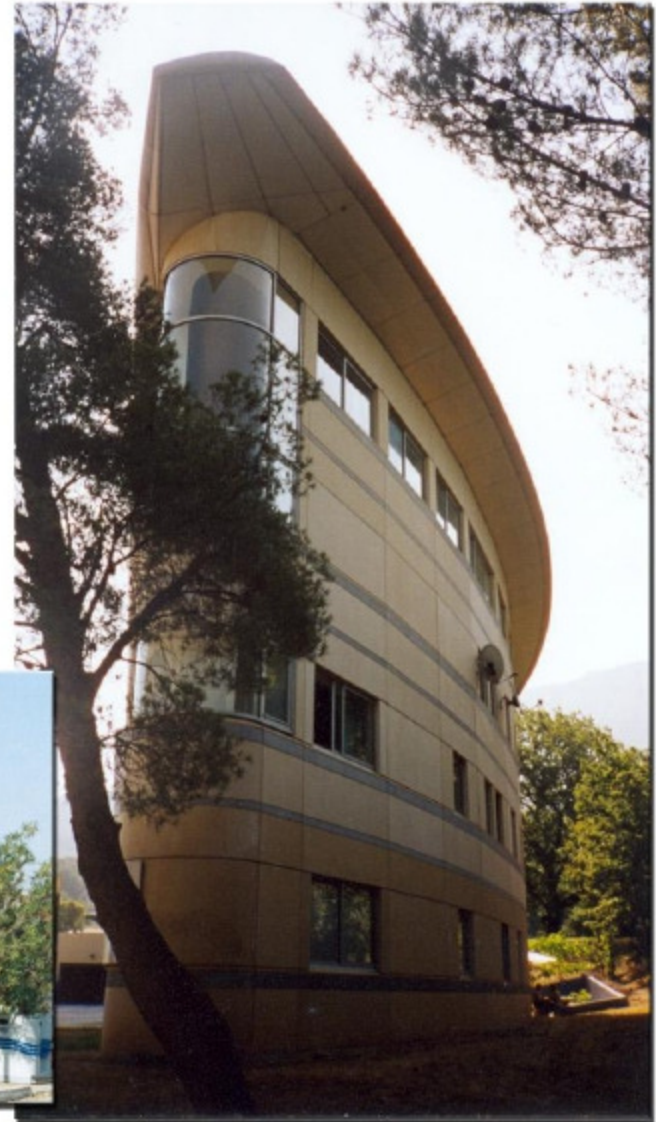
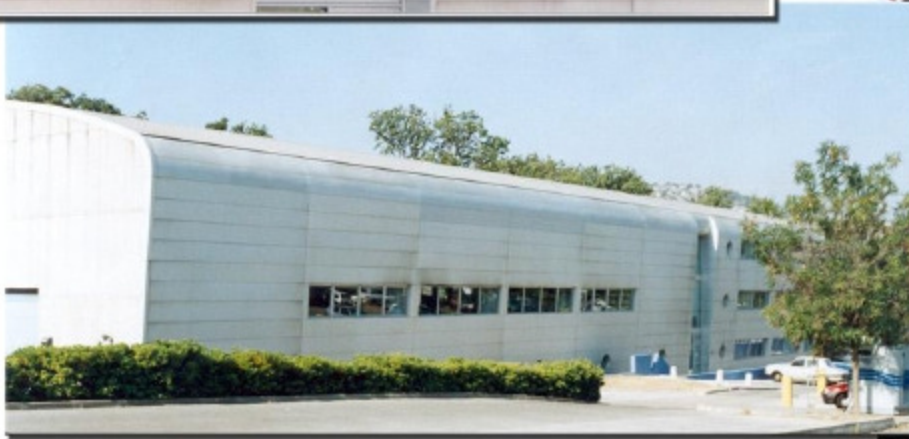
| Address of building | CENTRE DE PHYSIQUE DES PARTICULES 163, avenue de Luminy 13288 MARSEILLE - FRANCE |

| Visible signs of corrosion or surface degradation | None |
| Conclusion | After 10 years, no apparent signs of corrosion and no reduction in anodic film. |

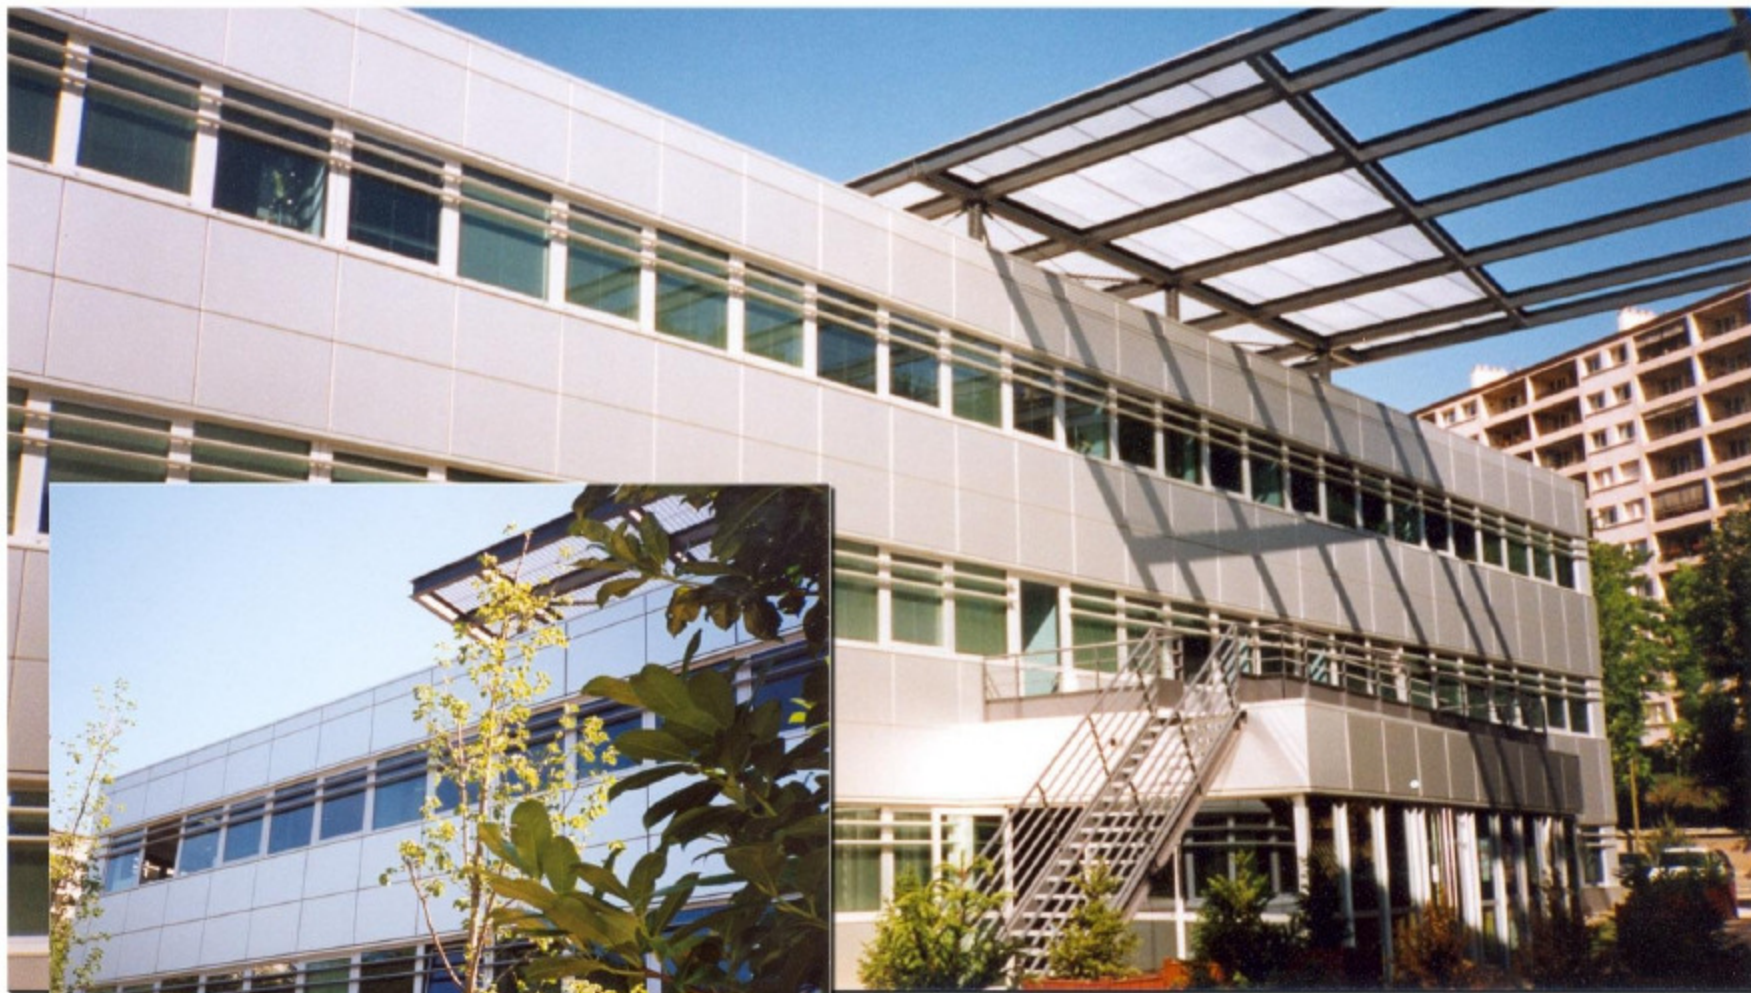
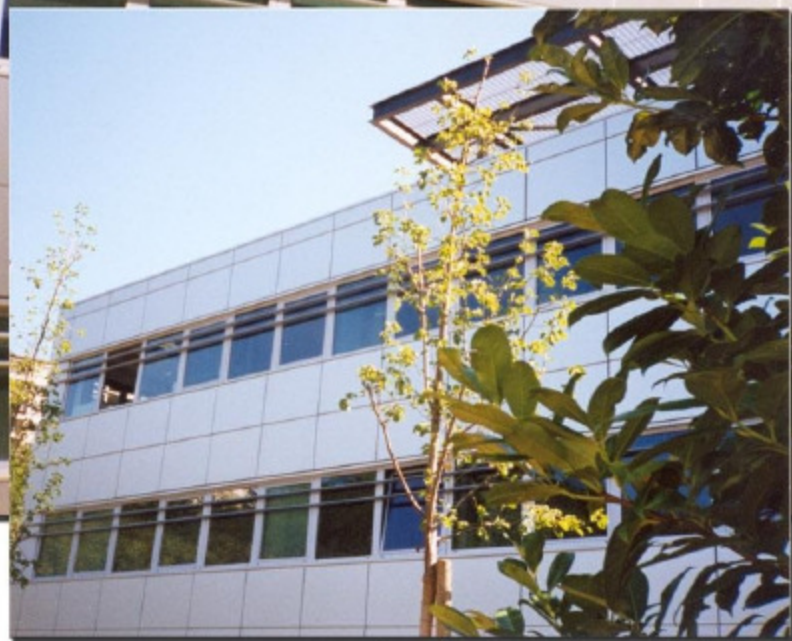
| Address of building | CONSEIL ECONOMIQUE ET SOCIAL REGIONAL REGION RHONE-ALPES SITE VALD'ECULLY 4, chemin du Ruisseau 69130 ECULLY-FRANCE |

| Visible signs of corrosion or surface degradation | None |
| Conclusion | After 2 years, no apparent signs of corrosion and no reduction in anodic film despite high density, polluted environment. |

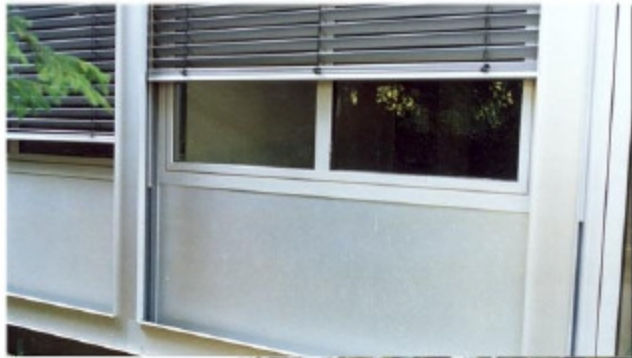
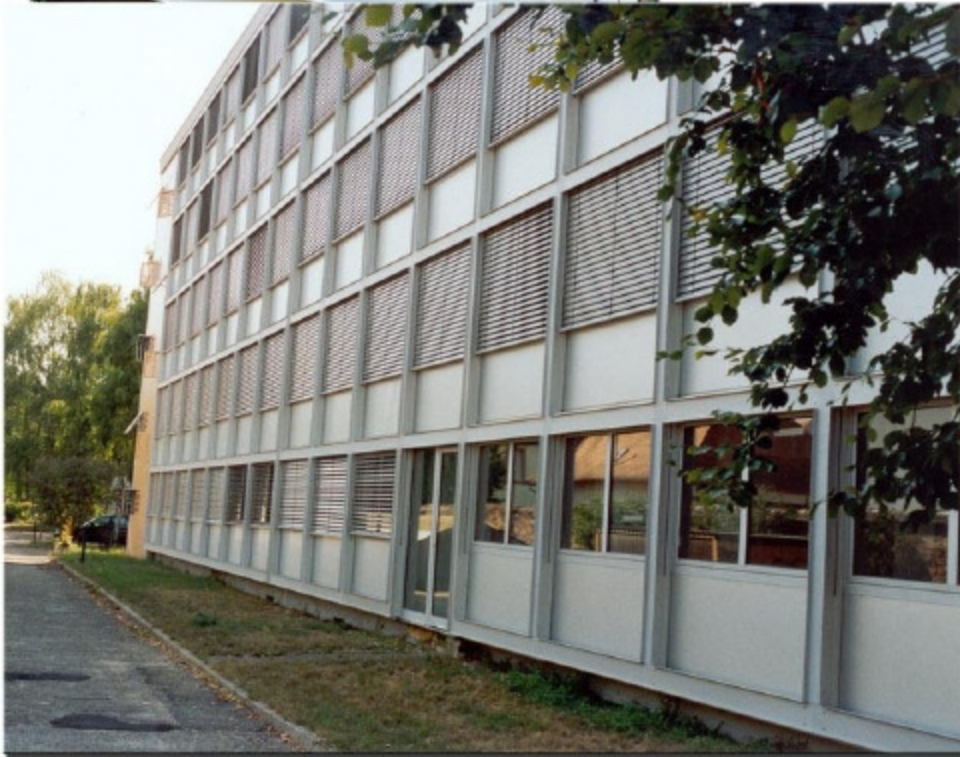
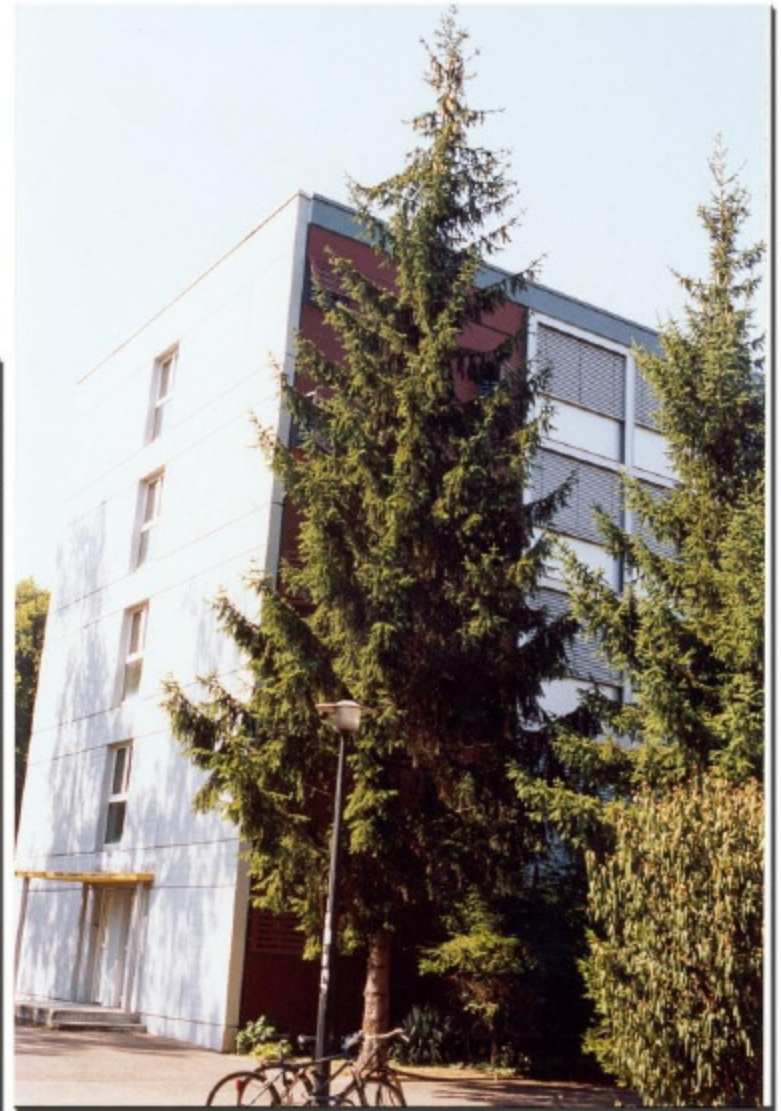
| Address of building | CITE UNIVERSITAIRE DE LA ROBERTSAU 14, route de la Wantzenau 67085 STRASBOURG-FRANCE |

| Visible signs of corrosion or surface degradation | None |
| Conclusion | After 5 years, no apparent signs of corrosion and no reduction in anodic film. |

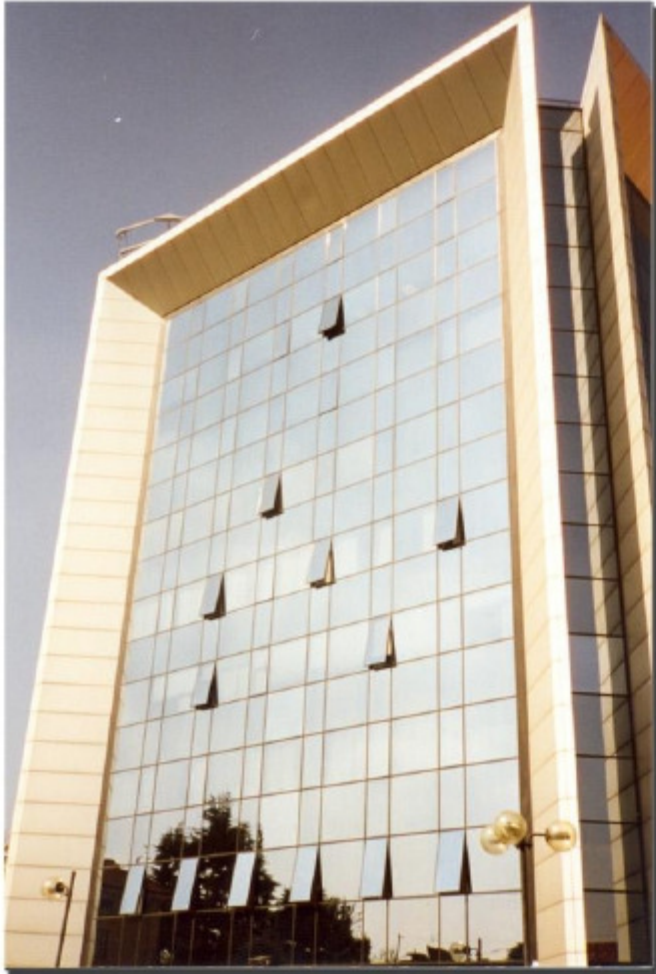
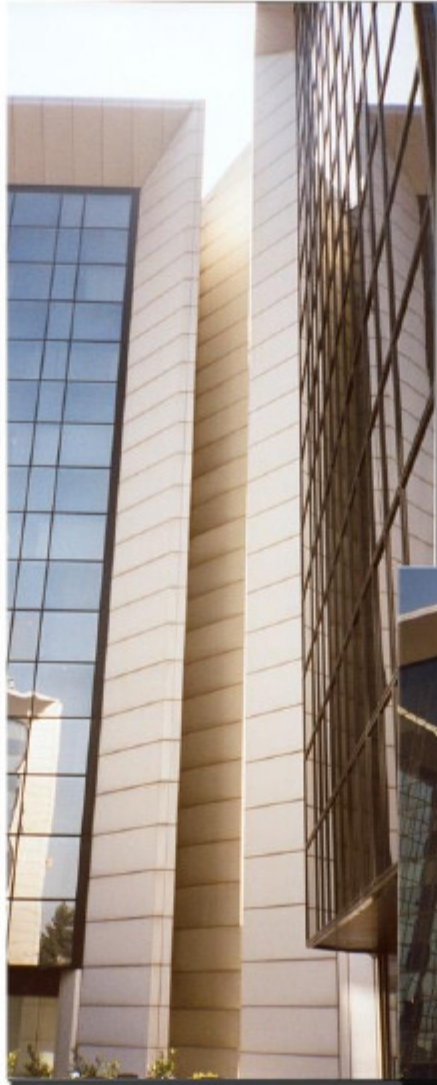
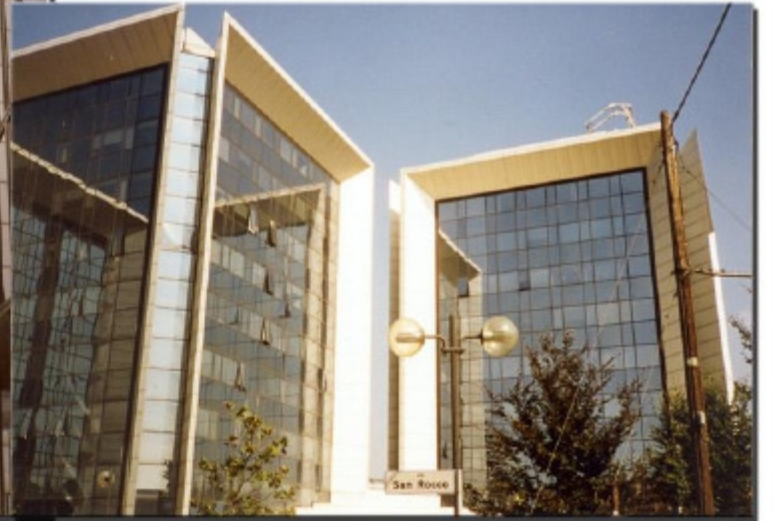
| Address of building | PÔLE TERTIAIRE DE GALLARATE-LETORRI Via Marsala 21013 GALLARATE-ITALY |

| Visible signs of corrosion or surface degradation | None |
| Conclusion | After 13 years, no apparent signs of corrosion and no reduction in anodic film. |
