Independently certified audit of the long term
on-site performance of continuously anodised
aluminium panels on exterior architectural
applications in Continental Europe

In 2002/3, Coil commissioned Dr. Laszlo Palffy, through his consultancy, Straditech, to jointly visit, with Coil technical staff, a number of buildings where continuously anodised panels had been extensively employed in the construction of the facade. Dr. Palffy has significant experience of the technology of anodising of aluminium.

The purpose of this audit was to assess the real long term on-site performance of continuously anodised panels compared to accelerated laboratory testing on which earlier conclusions had been based.

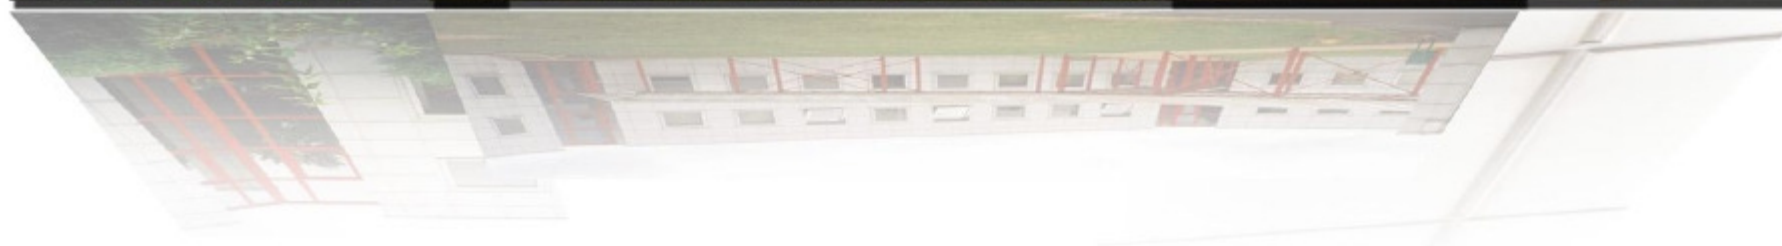
| Address of building | CENTRE EDF-GDF 4, avenue du Pacifique, ZA Courtaboeuf, 91940 LES ULIS - FRANCE |

| Visible signs of corrosion or surface degradation | None |
| Conclusion | After 20 years, no apparent signs of corrosion and no reduction in anodic film. |

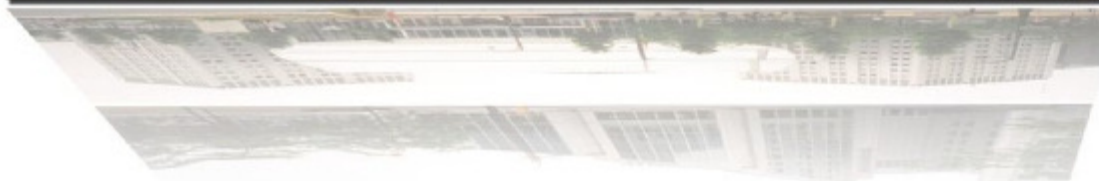
| Address of building | MINISTERE DE LA COMMUNAUTE FLAMANDE - BATIMENT BAUDOUIN 30, avenue Albert II 1000 BRUXELLES-BELGIUM |

| Visible signs of corrosion or surface degradation | None |
| Conclusion | After 23 years, no apparent signs of corrosion and no reduction in anodic film despite high density urban environment. |

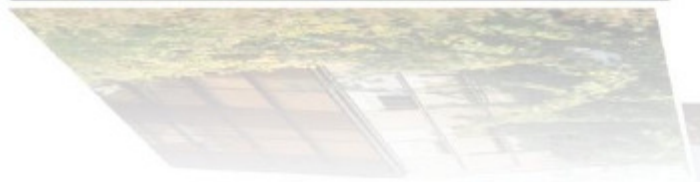
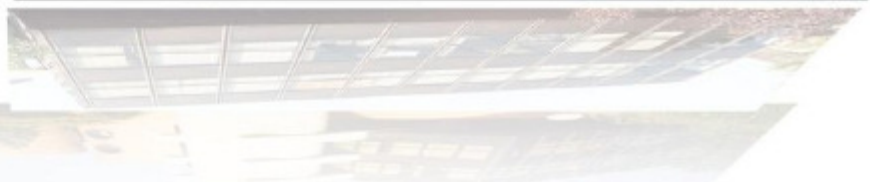
| Address of building | CAISSE REGIONALE DE CREDIT AGRICOLE 26, rue de la Godde 45800 SAINT JEAN DE BRAYE - FRANCE |

| Visible signs of corrosion or surface degradation | None |
| Conclusion | After 6 years, no apparent signs of corrosion and no reduction in anodic film. |
